APPENDIX L:
TDM AND LRPC POWER PLANT PHOTOGRAPHS

TDM POWER PLANT

LRPC POWER PLANT

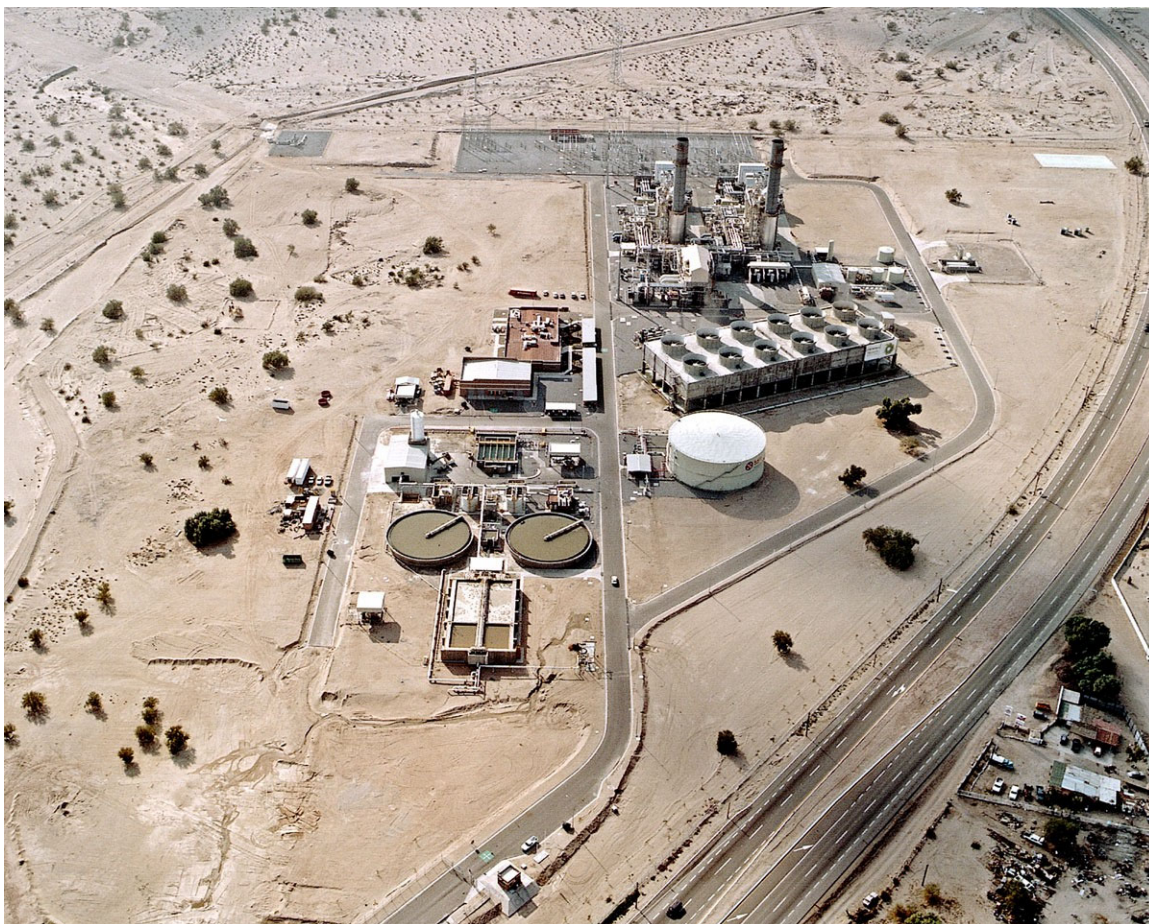
FIGURE L-1 Aerial View of the TDM Power Plant (North is to the right of the photograph. The facility property totals approximately 78.2 acres [31.7 ha]. The power plant and its facilities occupy approximately 26.8 acres [10.9 ha].)

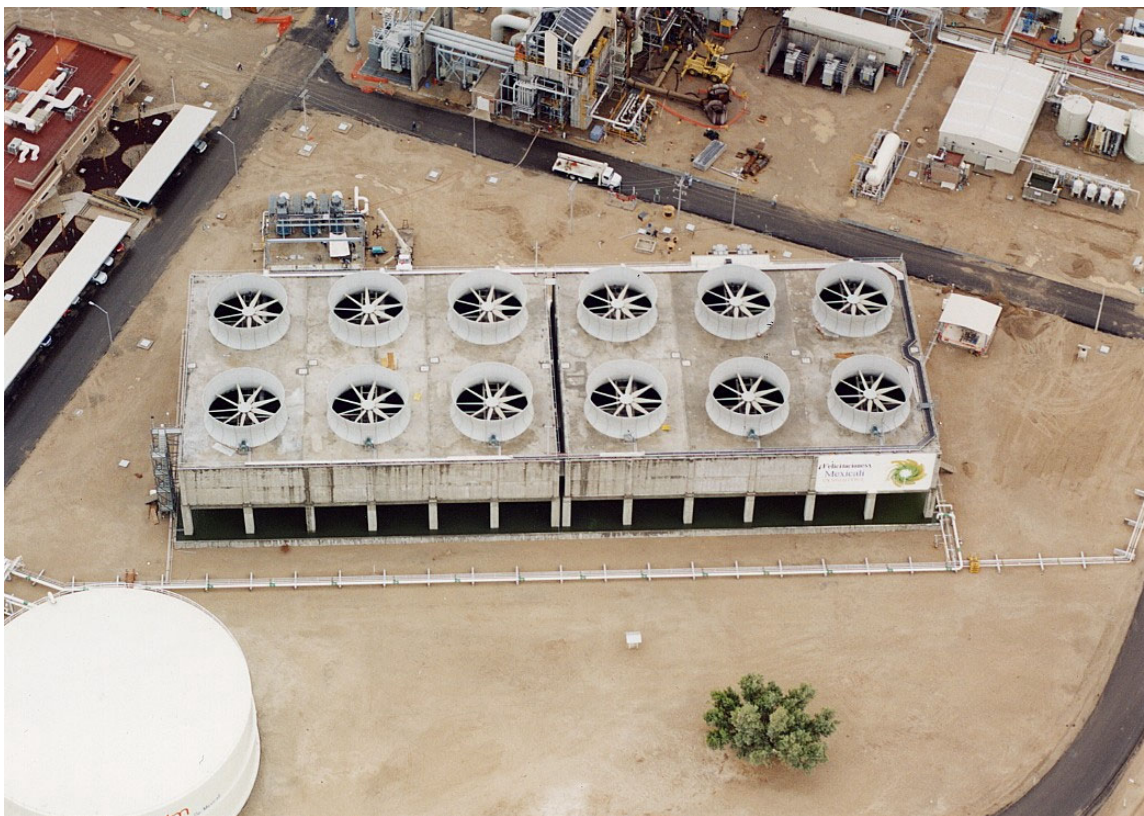
FIGURE L-2 Aerial View of the Cooling Tower (The cooling tower measures 350 ft [106.5 m] in length and 35 ft [41.1 m] in width, by 57 ft [17.4 m] in height. Each cooling fan measures 36 ft [11 m] in diameter. Note the truck on the road to the west of the cooling tower [north is to the right of the picture] for scale.)

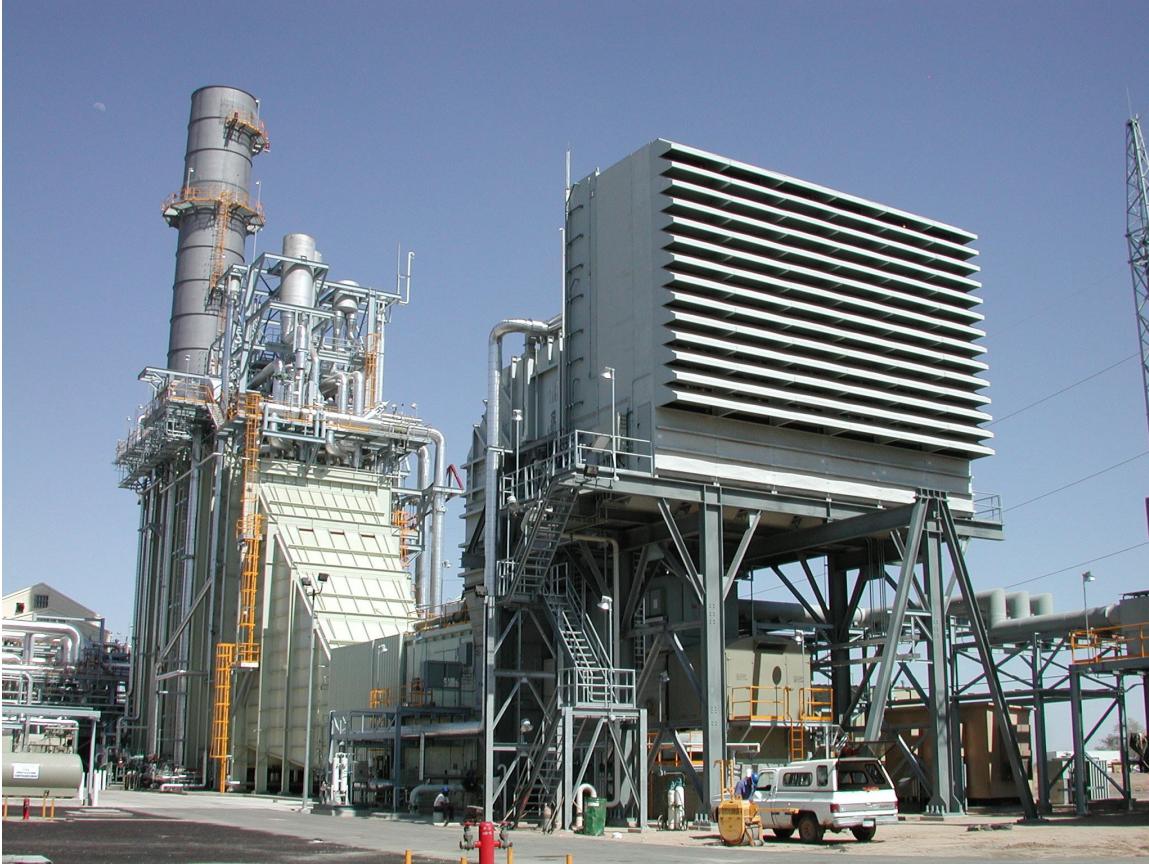
FIGUER L-3 View of Gas Turbine Inlet Air Structure, Gas Turbine, Heat Recovery Steam Generator, and Stack for One of the Two Units at TDM (The inlet air filter structure measures 69.5 ft [21.2 m] high from ground elevation, 44 ft [13.4 m] wide. The length of the turbine train front to back [from air filter structure to end of stack width] is 282 ft [86 m]. Note the pickup truck below inlet filters for scale.)

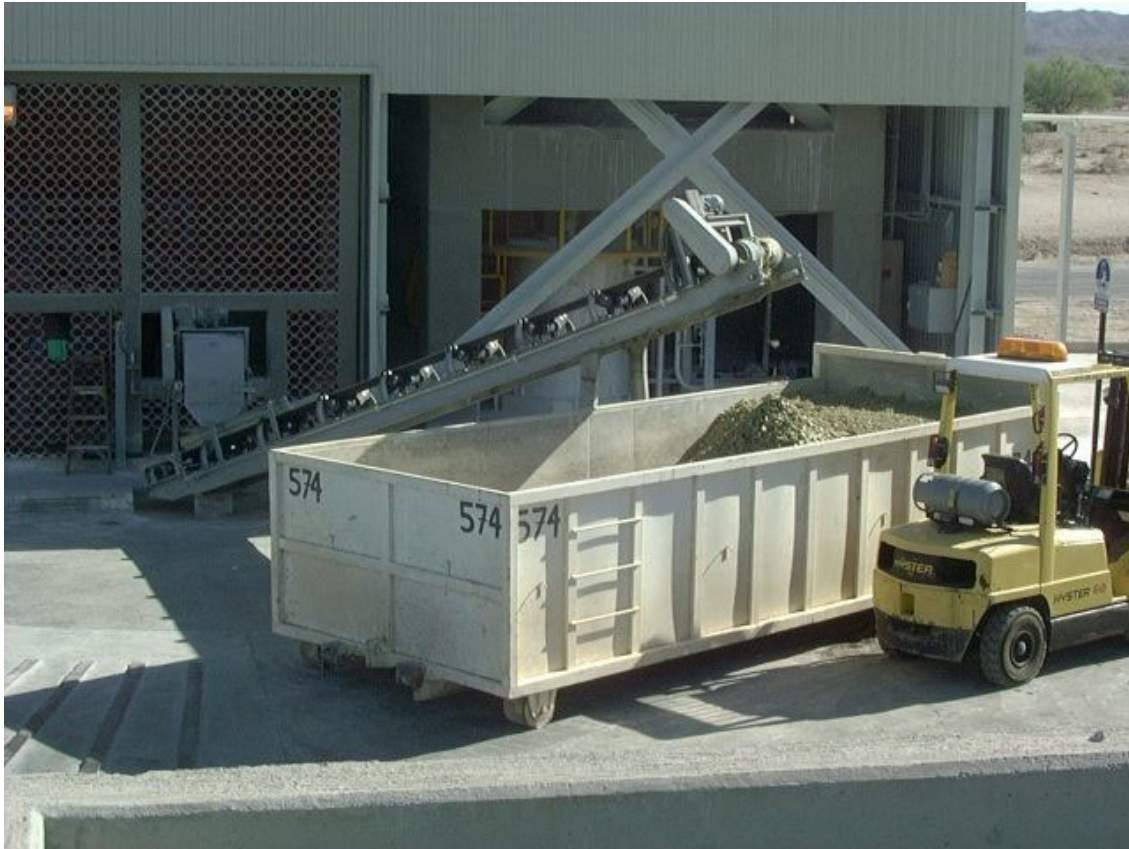
FIGURE L-4 View of Solids Removed from Sewage Treatment Processing at the TDM Facility (This is a view of the filter press house and the dump bin where solids are deposited for disposal in the solid waste landfill.)

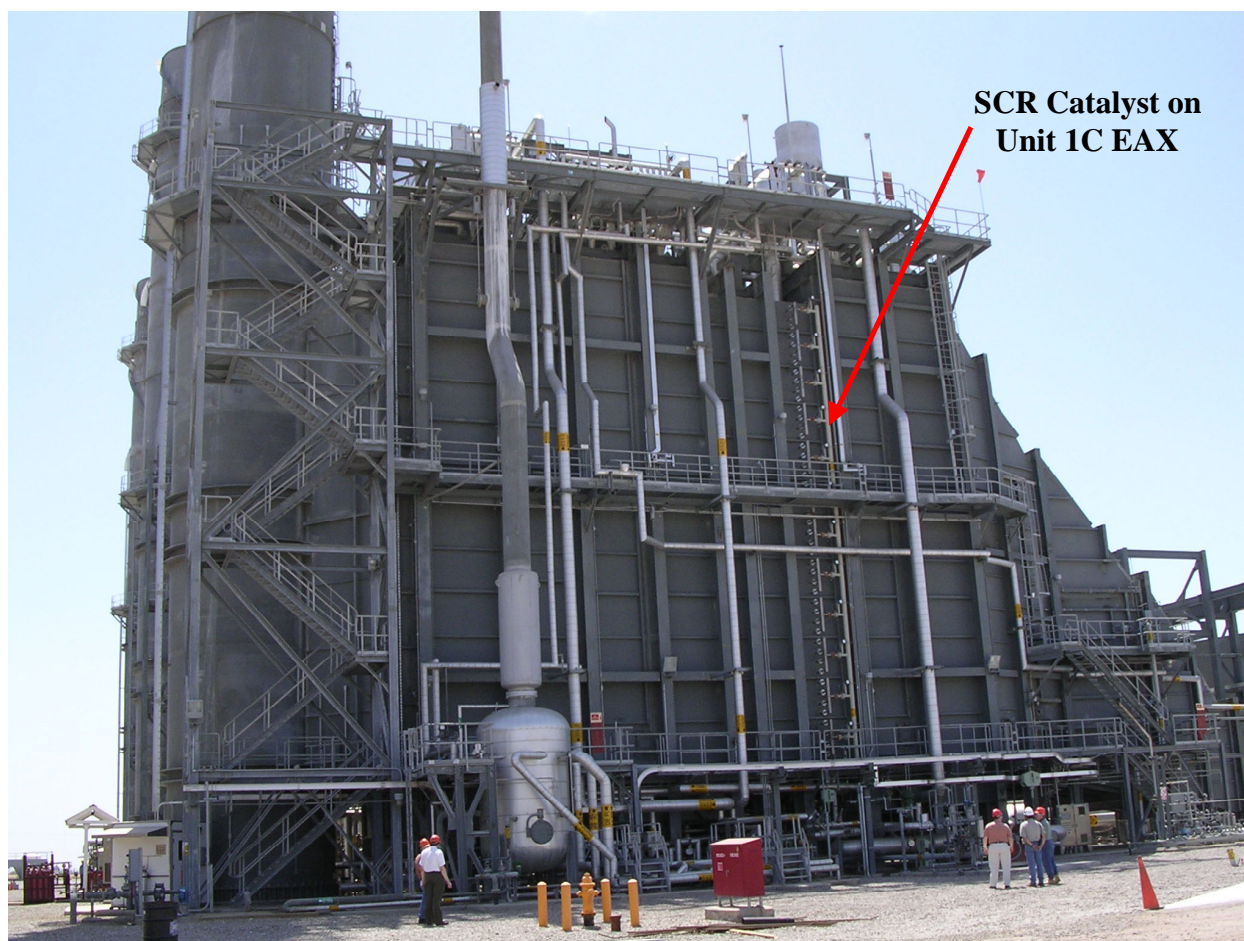
FIGURE L-5 View of EAX-1C Export Gas Turbine Showing the Location of the Selective Catalytic Reduction (SCR) System for NO_x Control Installed in March 2004 (If an oxidizing catalyst was installed under Alternative 3, it would be retrofitted in the vicinity of the SCR catalyst.)

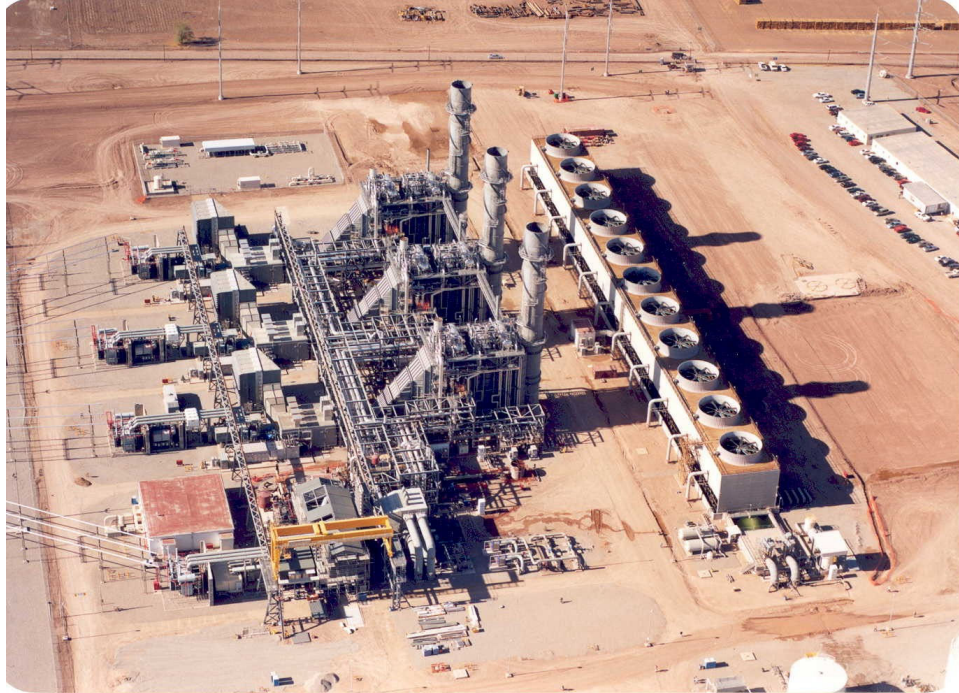
FIGURE L-6 Aerial View of LaRosita 1 (LR1), the EAX Unit (The 11-unit cooling tower is shown on the right and the three gas turbines on the left. Each of the gas turbines is equipped with a heat recovery steam generator that powers a single steam turbine in a combined-cycle mode.)

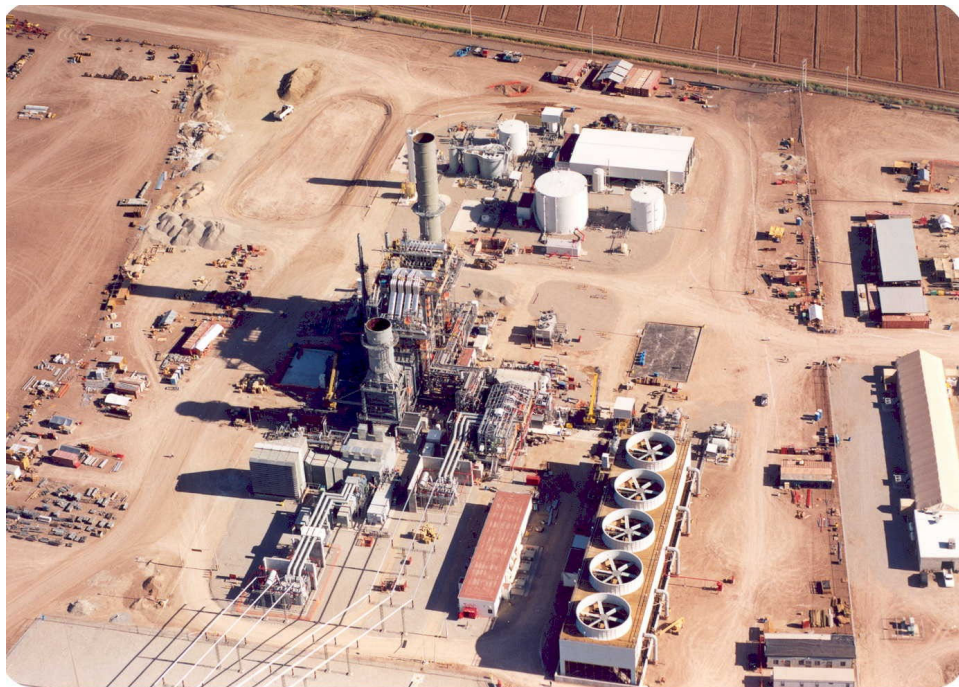
FIGURE L-8 Aerial View of LaRosita 2 (LR2), the EBC Export Unit
(This unit consists of a single gas turbine and a single steam turbine operating in a combined cycle. The on-site water treatment plant is near the top of the picture.)

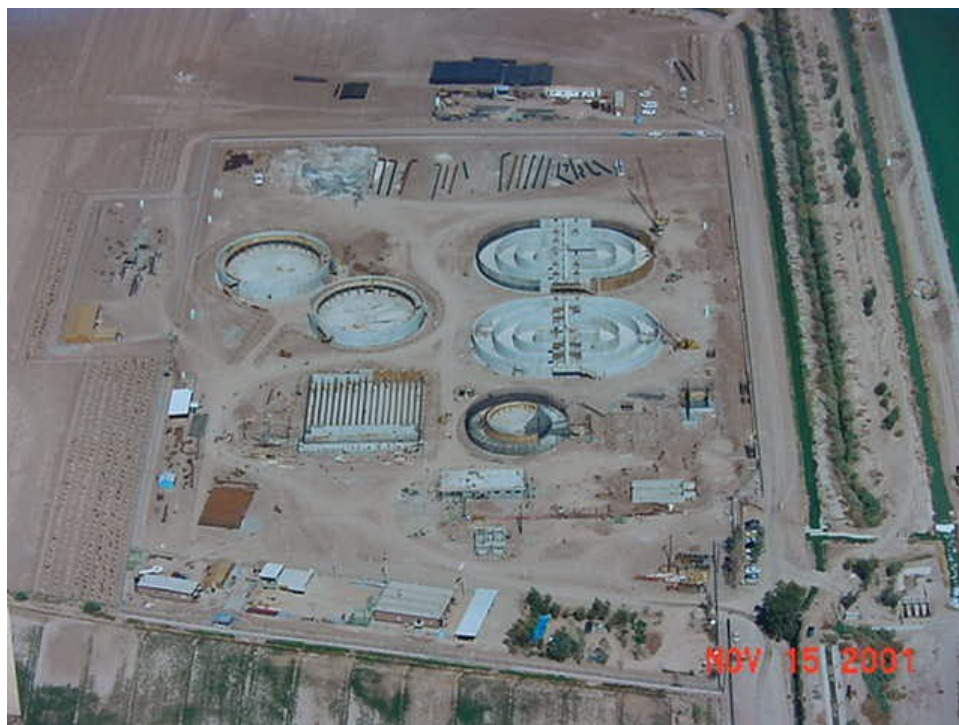
FIGURE L-10 Aerial View of the LRPC Sewage Treatment Plant next to the Zaragosa Oxidation Lagoons during Construction (November 2001)

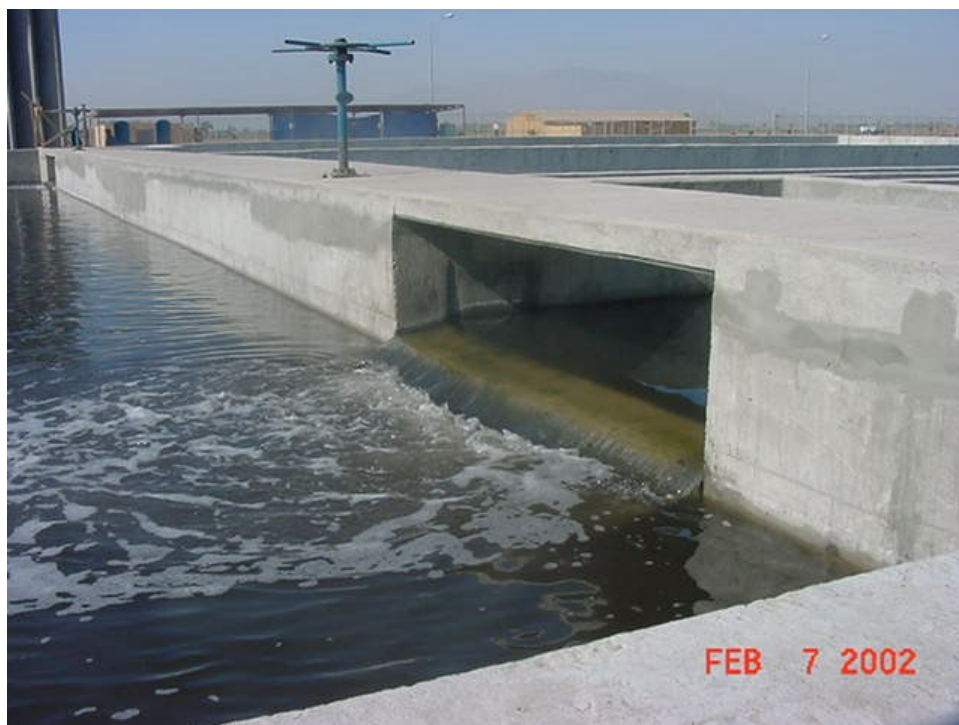
FIGURE L-11 Overflow from the Disinfection Chamber to the Gray Water Pump Well

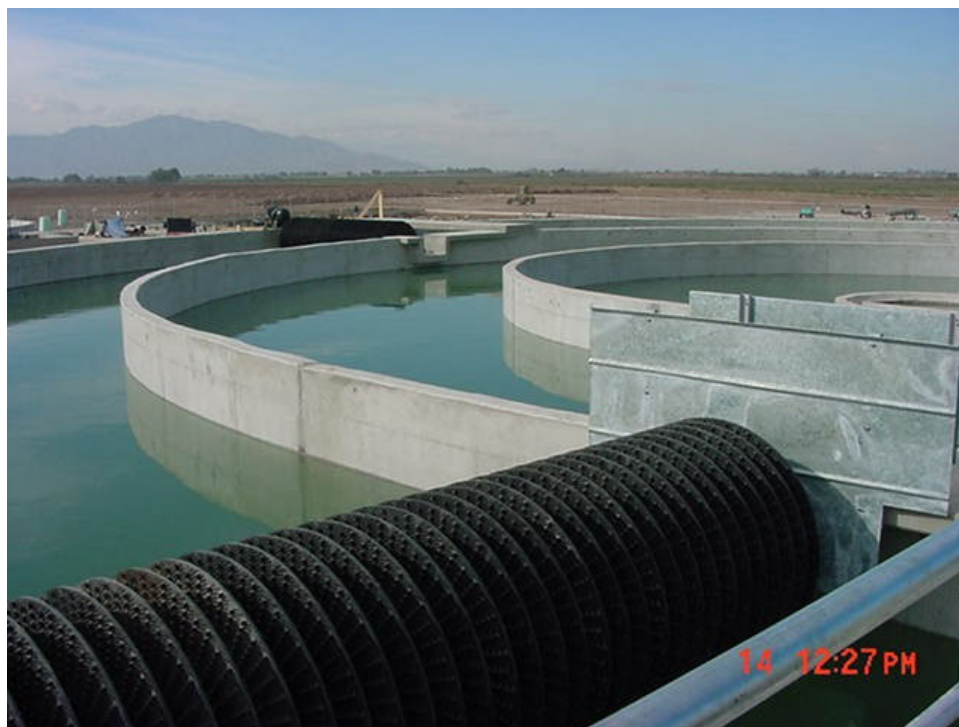
FIGURE L-12 Sewage Treatment Plant Aeration Tank
